## Service Bulletin No. 57

TO: Service Managers  
DATE: April 8, 1994  
RE: **Tales from the Crypt - Solid State Flipper Board**

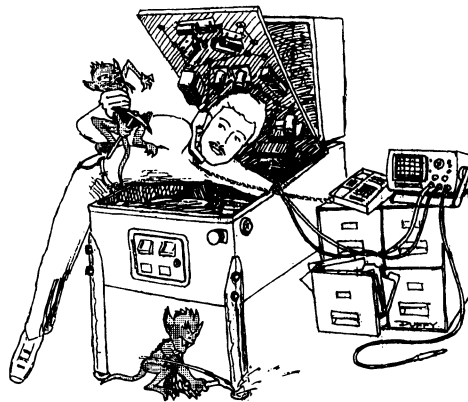
**Problem:** We have found on a few flipper boards, Resistor R36 was the incorrect value. This affects the pulse width of the 50 Volt Drive Signal that gives the flipper coil it's *kick*.

Correct = 2.2Meg

Incorrect = 2.2K

**Solution:** Replace R36 with the correct resistor value.

**Note:** *This is also a good troubleshooting tip in general due to the fact the 50 volt circuit is a one shot timed circuit of approximately 40 milli-seconds. Incorrect resistor values or values out of tolerance can affect the strength of the flipper.*
